Elmer Property, Patwon Gold Zone James Bay Region, Québec

An Orebody in the Making

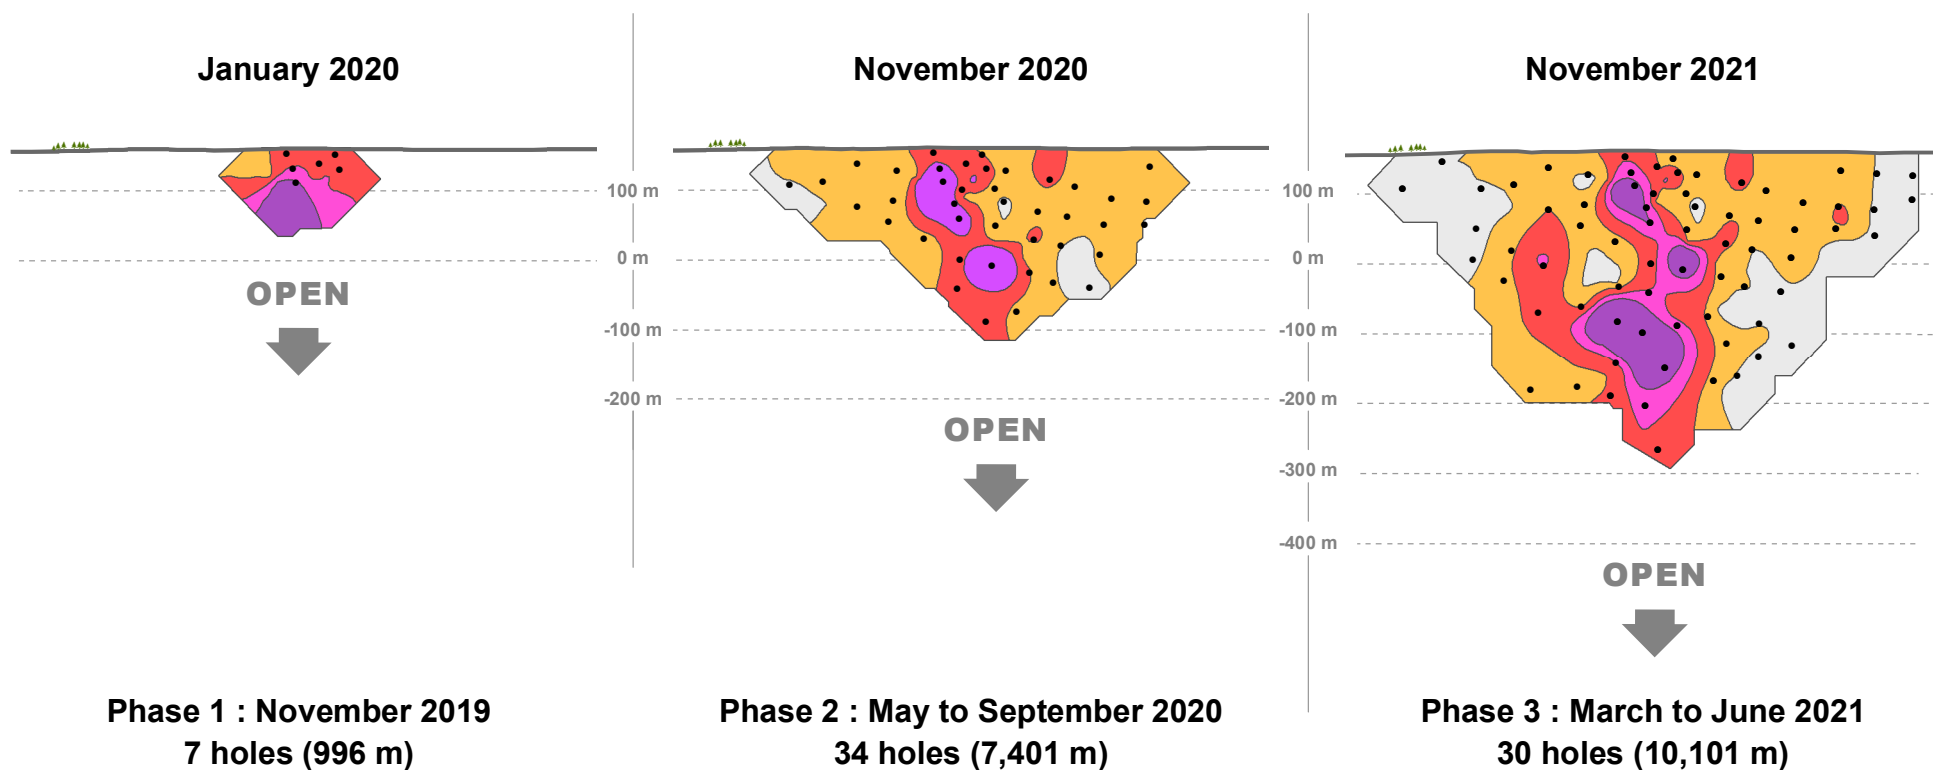
Figure 4 - Press release dated November 4, 2021

Elmer Property, Patwon Gold Zone, James Bay Region
Gridded gold grade x thickness using true width mineralized envelope
Longitudinal section - looking northwest, parallel to mineralized zone

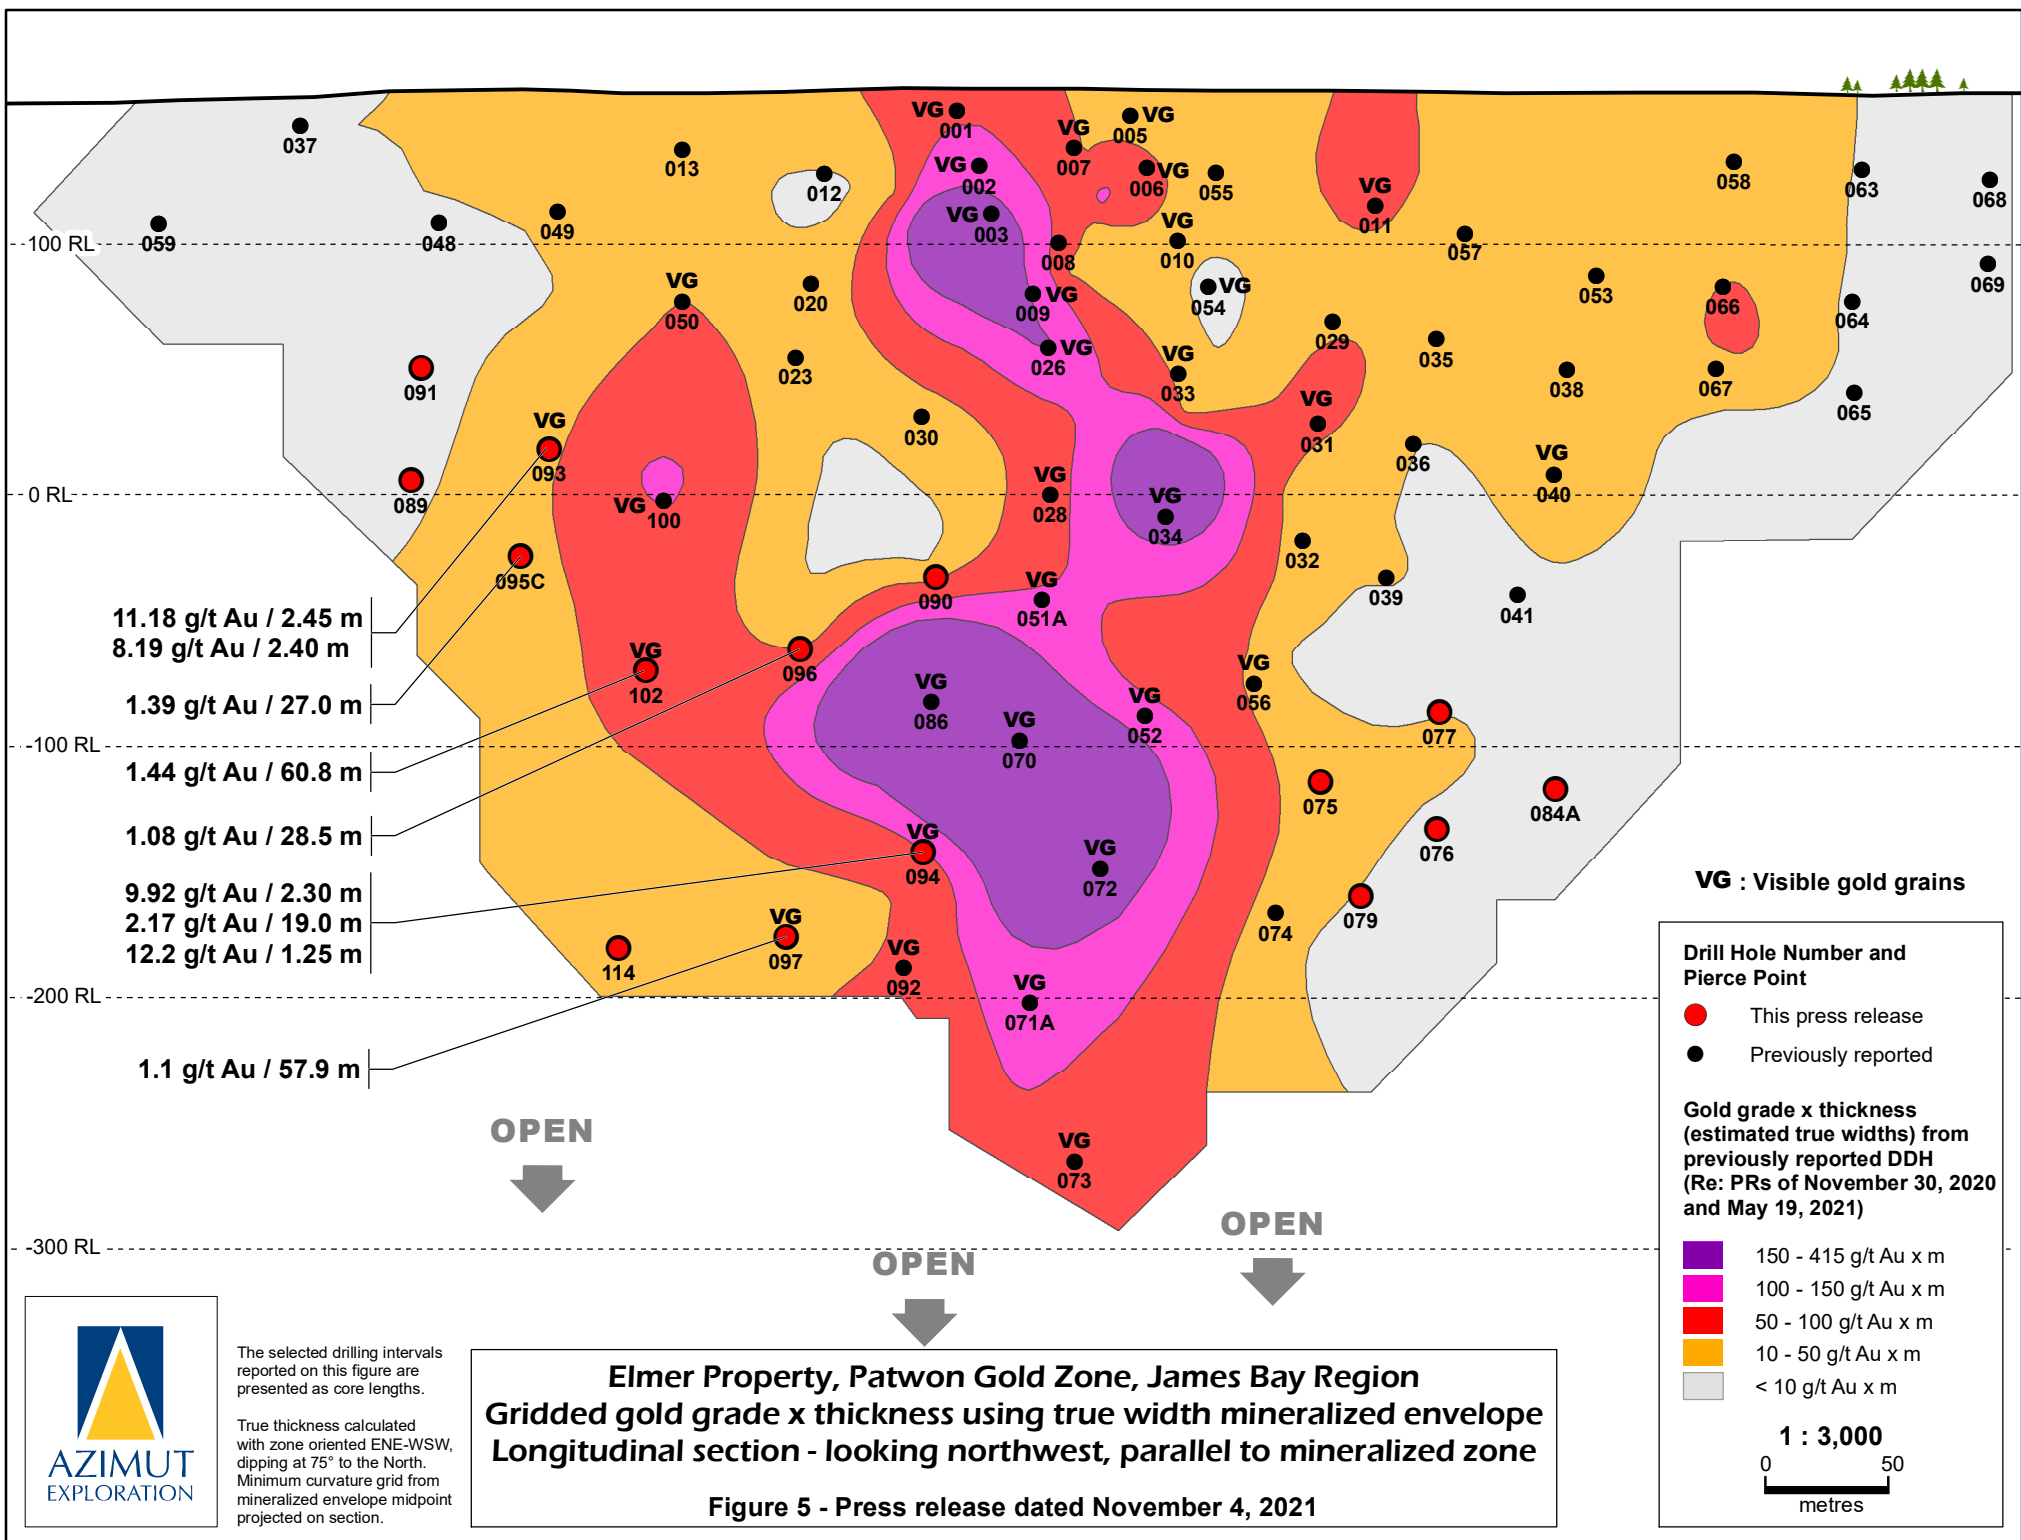
• Drill Hole Pierce Point
